5 Experimental Results¹

5.1 Data Analysis

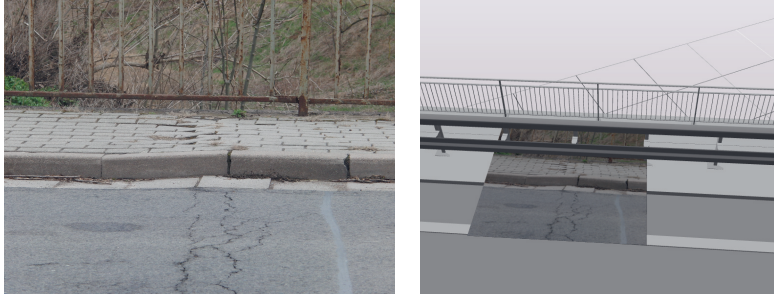
Figure 5.11 shows some cracks on the pavement of the bridge. Furthermore, there is a bump in the pavement and the side walk. Only by using this photo as a texture, the inspector or engineer can get a quick impression of the defect. Aligning the texture to the 3D model can help the user gather additional information about related or near elements faster compared to studying 2D plans. However, this defect shows the problem of image

Figure 5.11: Representation of some cracks at the pavement as a texture depicted on a plane.

rectification for textures. The image, which has been used for the texture, has not been rectified. Hence, the texture shows the slope of the bridge at the position of the sidewalk, which could be misunderstood.

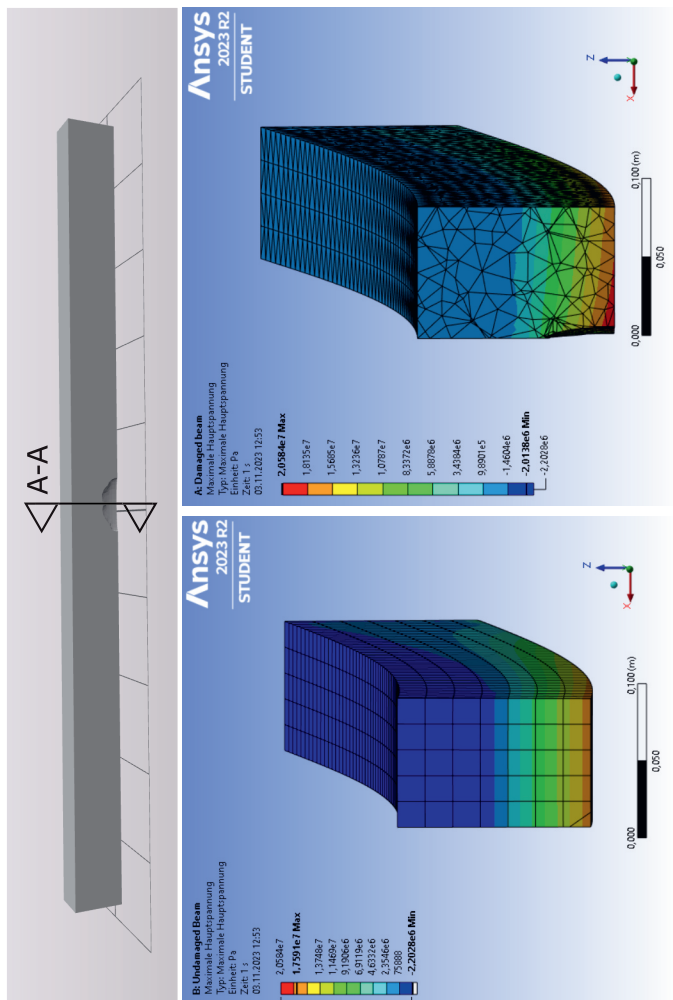
To see the potential effect on the principal stress of the defect, Figure 5.15 shows the maximum principal stress of the undamaged (left) and damaged (right) beam. The cut plane for this illustration is approximately at 1m from the left side and illustrated in Figure 5.15 top. The Figure shows that there is a bigger strain in the bottom part especially near the defect. However, this example is to illustrate the use of such geometric models for structural analysis. Problems could be the different meshes of both geometries as evident from the screenshots. Furthermore, the beam has to be modeled with respect to the entire structural system of bridge, which would influence bearings, loads and so on. Advantageous is the usability of existing geometric models to analyze building components in detail. Several of such models for important bridge components may be analyzed in parallel and would provide detailed information to, e.g., predict components vulnerable to defects.

Figure 5.15: Top: cut plane. Bottom: cut plane. Bottom: cut plane for the undamaged and damaged beam.
