## 5 Experimental Results<sup>1</sup>

## 5.2 Information Modeling

## 5.4 Proof of Concept

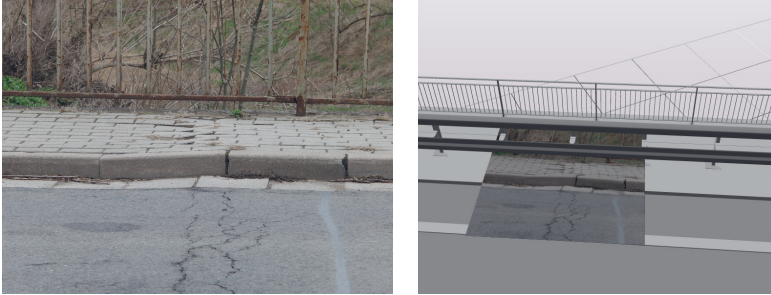
Figure 5.11 shows some cracks on the pavement of the bridge. Furthermore, there is a bump in the pavement and the side walk. Only by using this photo as a texture, the inspector or engineer can get a quick impression of the defect. Aligning the texture to the 3D model can help the user gather additional information about related or near elements faster compared to studying 2D plans. However, this defect shows the problem of image

Figure 5.11: Representation of some cracks at the pavement as a texture depicted on a plane.

rectification for textures. The image, which has been used for the texture, has not been rectified. Hence, the texture shows the slope of the bridge at the position of the sidewalk, which could be misunderstood.
