5 Experimental Results¹

5.1 Data Analysis

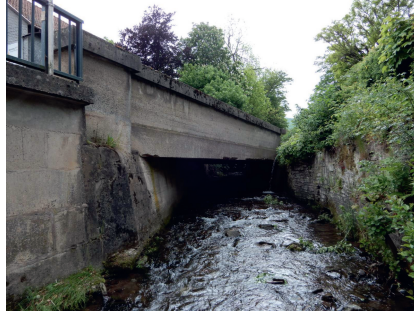
Figure 5.6: Photo of the bridge for case study. The photo has been provided by the "Thüringer Landesamt für Bau und Verkehr".

Figure 5.6 shows the bridge that has been used for this case study. The photo has been provided by the "Thüringer Landesamt für Bau und Verkehr". A 3D model has been created via Revit, exported as IFC file and extended with the automatically generated damage geometry and semantics [5]. The bridge is approximately 14 m long. Because this is a short bridge, modeling was done manually. Further tests and evaluation may require long span bridges.
