5 Experimental Results¹

5.2 Information Modeling

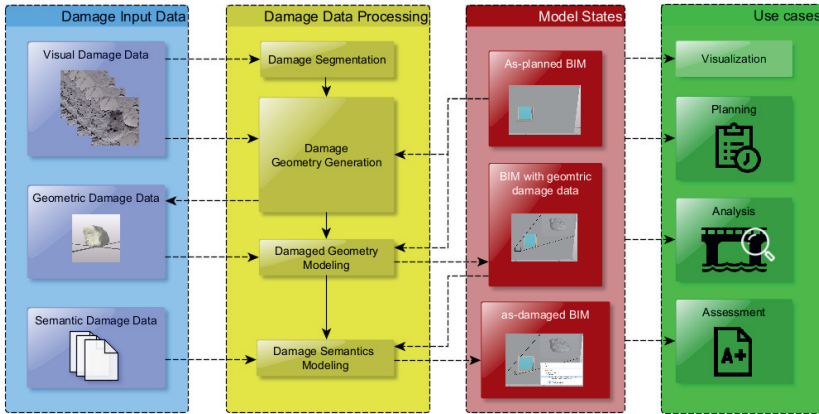
Figure 5.5 shows an exemplary framework from Artus, Alabassy, and Koch [5]. In this framework, photos are used to generate the point cloud of the bridge, identify defects and generate damage geometries. This data is added to the as-built model. Later, further semantic data is added.

Figure 5.5: Overview of the framework with the damage input data, damage data processing, model states, and possible use cases. Originally published by Artus, Alabassy, and Koch [5]. Pictograms have been taken from icons8 [161]–[164].
