## 5 Experimental Results<sup>1</sup>

## 5.4 Proof of Concept

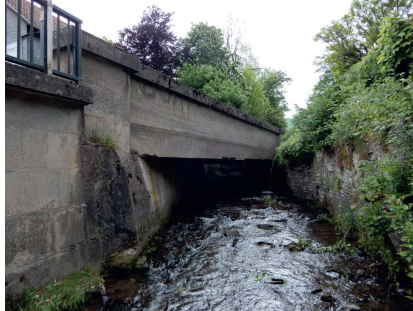
Figure 5.6 shows the bridge that has been used for this case study. The photo has been provided by the "Thüringer Landesamt für Bau und Verkehr". A 3D model has been created via Revit, exported as IFC file and extended with the automatically generated damage geometry and semantics [5]. The bridge is approximately 14 m long. Because this is a short bridge, modeling was done manually. Further tests and evaluation may require long span bridges.

Figure 5.6: Photo of the bridge for case study. The photo has been provided by the "Thüringer Landesamt für Bau und Verkehr".

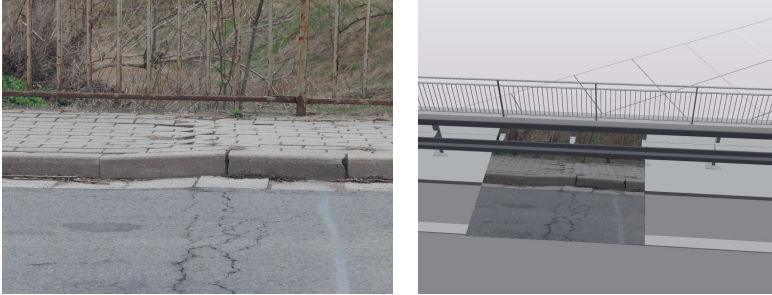
Figure 5.11 shows some cracks on the pavement of the bridge. Furthermore, there is a bump in the pavement and the side walk. Only by using this photo as a texture, the inspector or engineer can get a quick impression of the defect. Aligning the texture to the 3D model can help the user gather additional information about related or near elements faster compared to studying 2D plans. However, this defect shows the problem of image

Figure 5.11: Representation of some cracks at the pavement as a texture depicted on a plane.

rectification for textures. The image, which has been used for the texture, has not been rectified. Hence, the texture shows the slope of the bridge at the position of the sidewalk, which could be misunderstood.

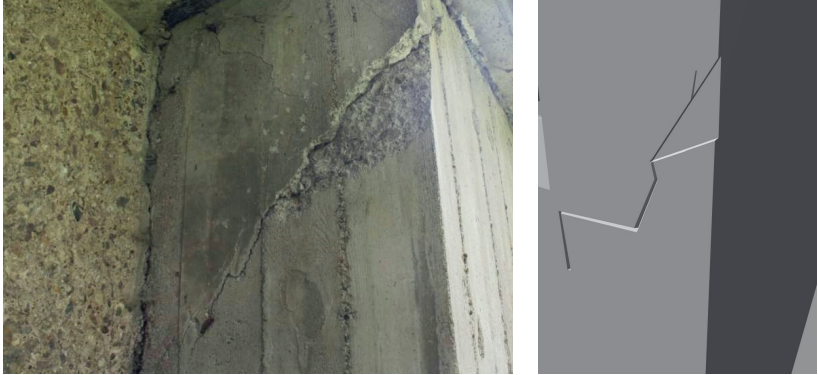
Figure 5.12: Representation of a spalling at the abutment.
