5 Experimental Results¹

5.2 Information Modeling

5.4 Proof of Concept

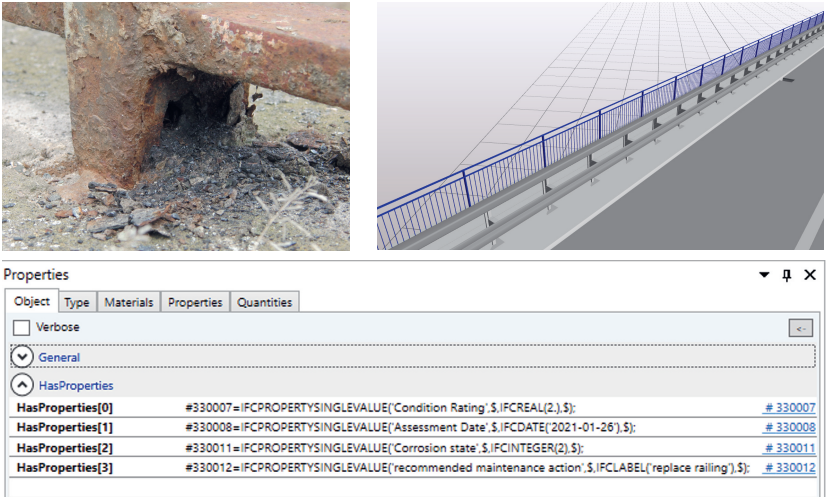
Figure 5.10 shows a photo of a corroded railing at the top-left position. Right next to this photo is the selected railing in the model. The bottom screenshot shows the properties of the railing in the model. Taking adequate photos to represent the corrosion of the entire railing is cumbersome and time consuming. Therefore, a simple property is used to represent this defect. The railing has only a body geometry, and hence, if the damaged component geometric representation context is selected, the railing is not shown anymore in the 3D view. This defect revealed that it is not fully sufficient to use geometric representation contexts for selection. Specialized views are necessary, such as a view with highlighted components or damage textures.

Figure 5.10: On the top left a photo of the corroded railing on-site. The selected railing is right next to the photo in the model visualized by xBIM Explorer. On the bottom, the figure shows the related property set with a condition rating, an assessment date and further information.

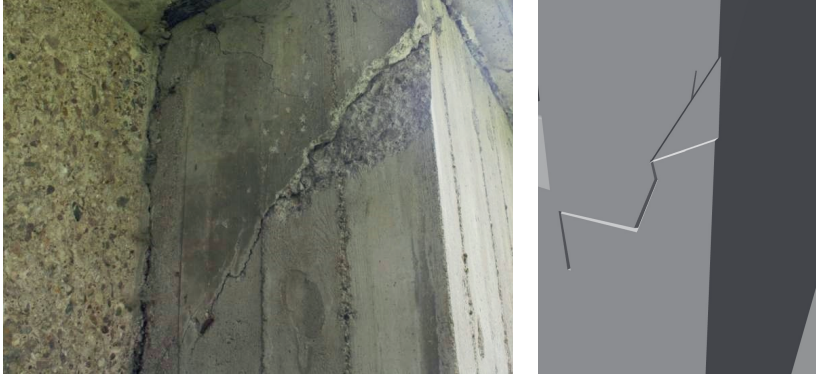
Figure 5.12: Representation of a spalling at the abutment.
