5 Experimental Results¹

5.1 Data Analysis

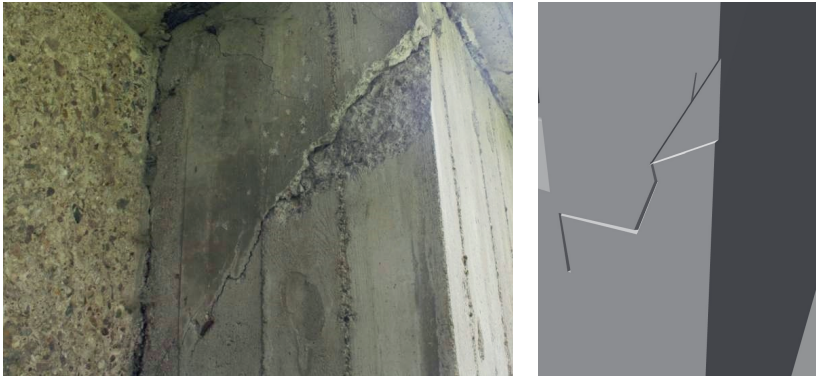
Figure 5.12: Representation of a spalling at the abutment.

Figure 5.12 shows an example of a geometric representation of a defect. The left side of Figure 19 shows a photo of the spalling, and the right side shows the defect in the final model. The geometry of the spalling was generated manually within the IFC file. This leads to the visual inaccuracies, such as the different paths of the lower part of the spalling. By using SfM, damage geometries can be modeled with higher accuracy [60]. However, the example shows that the principal concept provides geometry information of a defect.
