## 5 Experimental Results<sup>1</sup>

## 5.2 Information Modeling

## 5.4 Proof of Concept

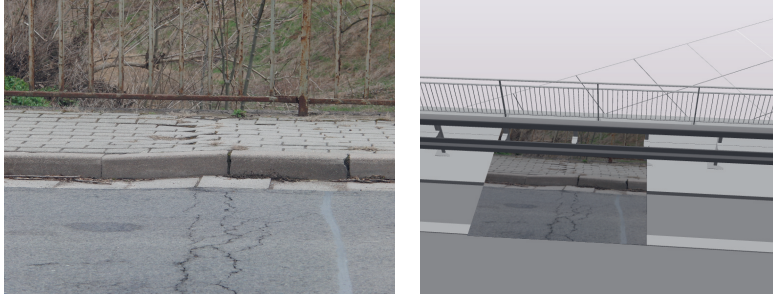
Figure 5.11: Representation of some cracks at the pavement as a texture depicted on a plane.

Figure 5.11 shows some cracks on the pavement of the bridge. Furthermore, there is a bump in the pavement and the side walk. Only by using this photo as a texture, the inspector or engineer can get a quick impression of the defect. Aligning the texture to the 3D model can help the user gather additional information about related or near elements faster compared to studying 2D plans. However, this defect shows the problem of image

rectification for textures. The image, which has been used for the texture, has not been rectified. Hence, the texture shows the slope of the bridge at the position of the sidewalk, which could be misunderstood.

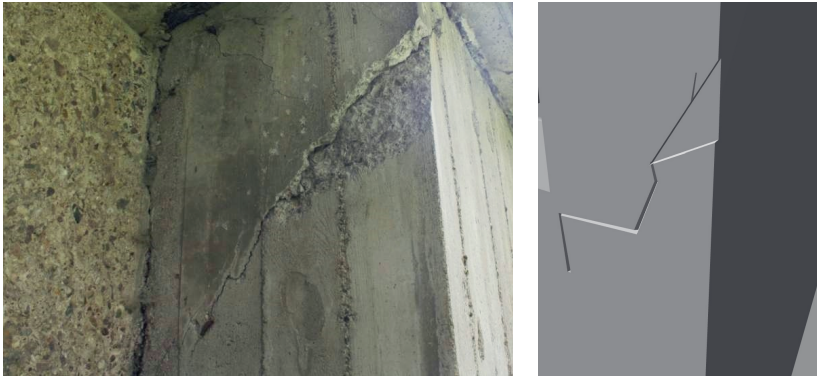
Figure 5.12: Representation of a spalling at the abutment.
